INSPECTION SUMMARY

Mitsubishi ASX 2017

JE4LP21U8HZ704403 | 153083 KM | GCC Specs

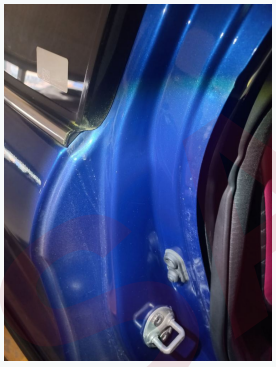
Damage photo 1 — Right center pillar repaired

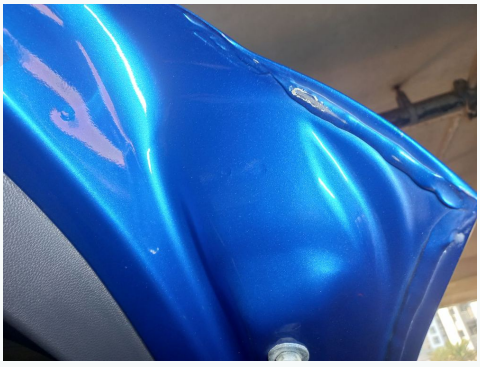
Damage photo 2 — Right back door replaced
