INSPECTION SUMMARY

Porsche CAYENNE GTS 92A 2016

WP1ZZZ92ZGLA76381 | 125861 KM | GCC Specs

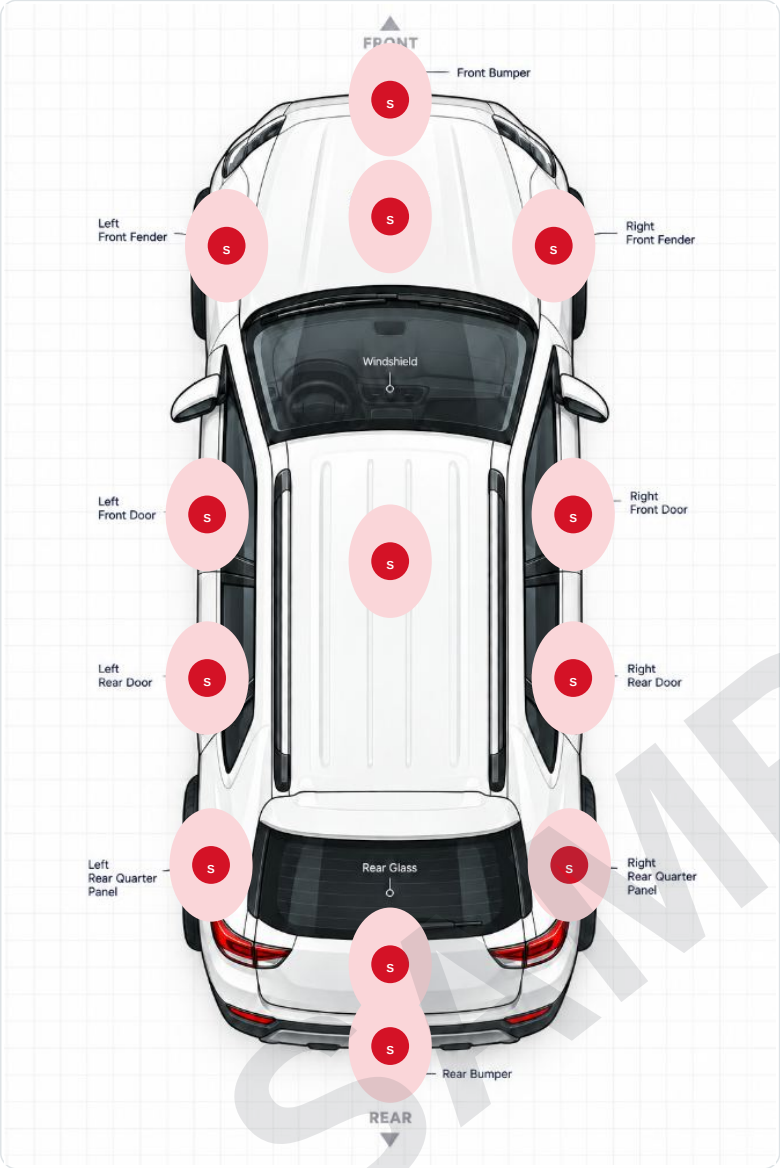
VEHICLE BODY CONDITION DIAGRAM

S — Paint Shower / Spray Only

Engine block oil leakage. Gear major oil leakage. Engine Cam noise. Right side Gear Axle Leakage. Air suspension pump need to replace. Overall car outside and inside repainted
